HIGH-TEMPERATURE MECHANICAL PROPERTIES OF SINTERED ALPHA SILICON CARBIDE (13 Oct 1978 - 13 Oct 1979)

February 19, 1980

Office of Naval Research Department of the Navy

Under Contract N00014-76-C-0249

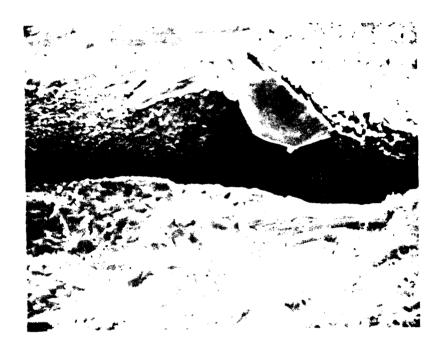
Unusually large surface grains that were the cause of failure are shown in Figure 5-6. It is well known that the strength of ceramic materials decreases with increasing grain size, so it is not surprising that several large grains would be the fracture origin on the tensile surface. The sharp angles between these large grains may have enhanced the stress concentation at this particular point.

Figure 5-6. Large Surface Grains at the Fracture Origin of an ONR-2 Specimen for Sample 2, Group 3 (350X)
